DOCUMENT 403-92

SYSTEM TRACKING ACCURACY AND OPERATIONAL ACCEPTANCE TESTING OF THE AUTEC SONOBUOY TRACKING SYSTEM (STS)

JULY 1992

UNDERWATER SYSTEMS GROUP RANGE COMMANDERS COUNCIL

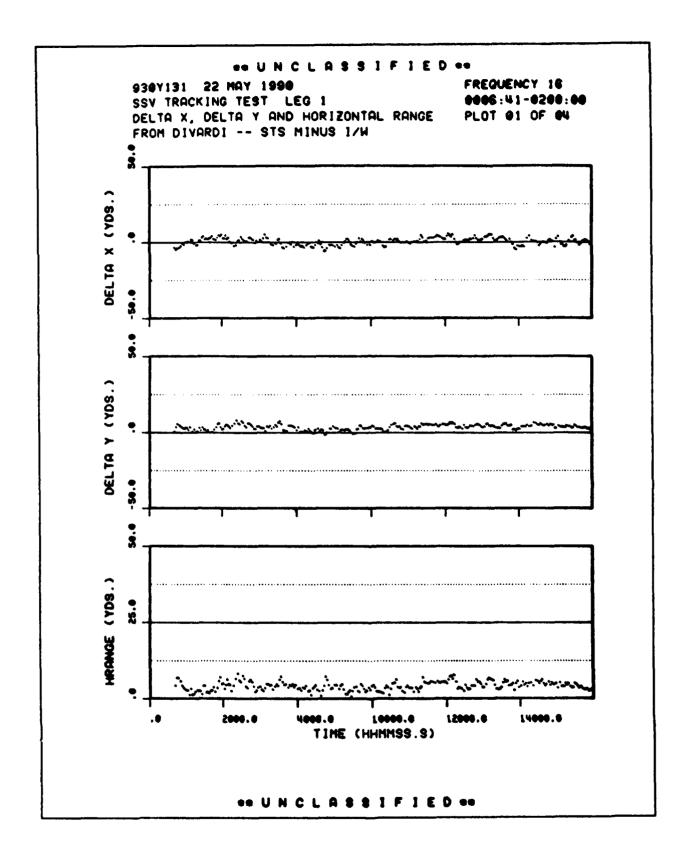
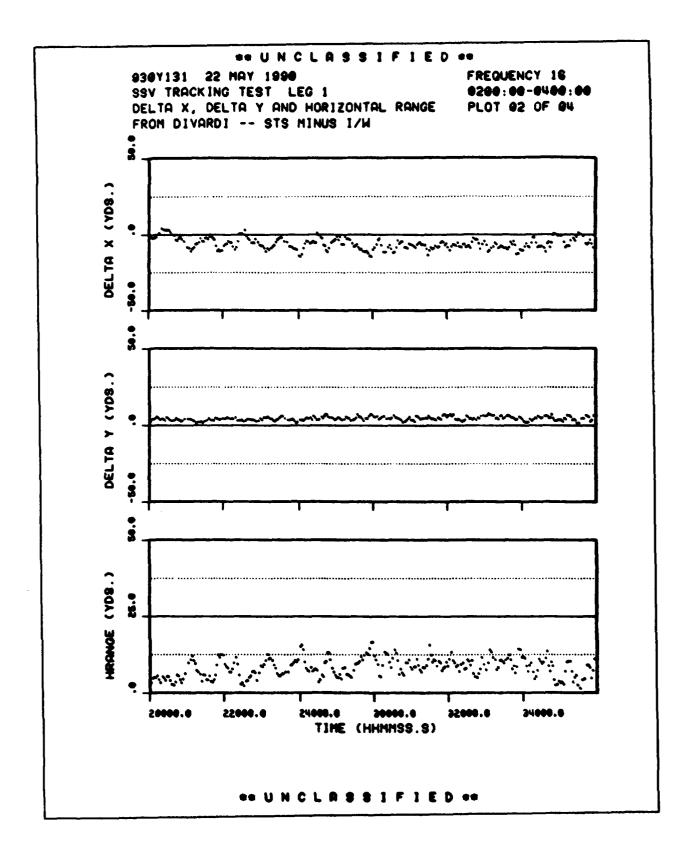
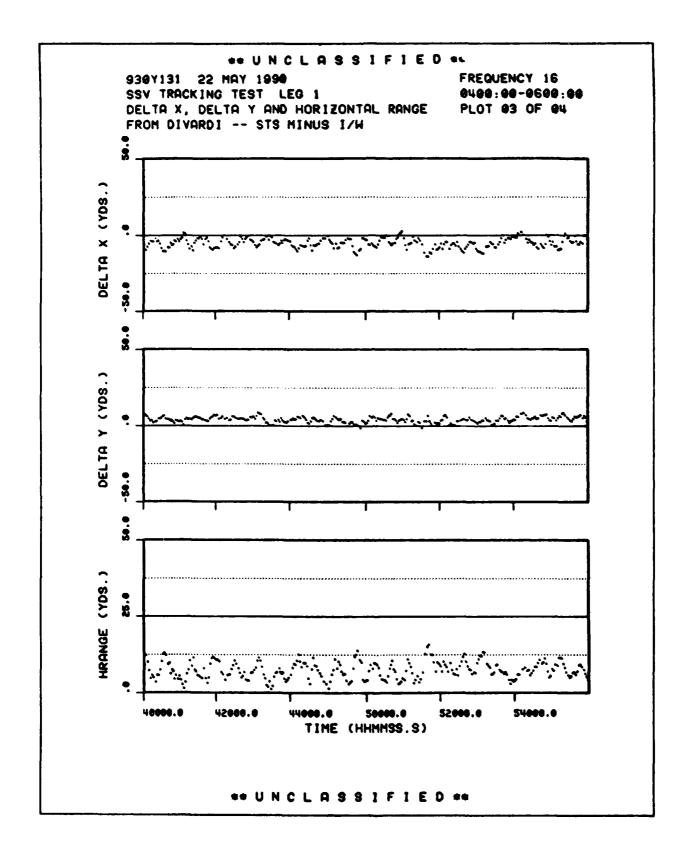
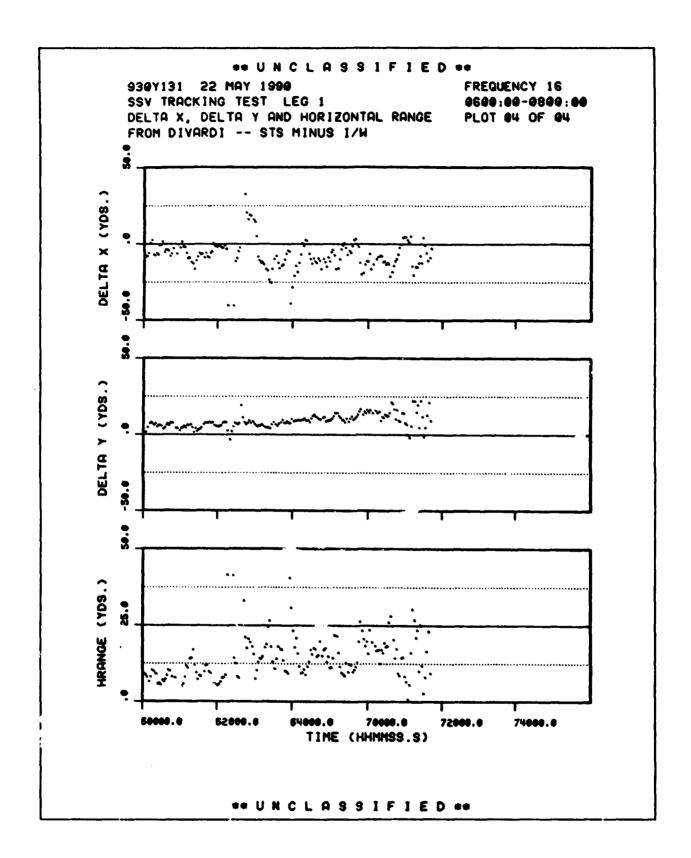
Typical for SSV tracking, figures 5 through 7 are plots of position differences between STS and I/W as a function of time for three channels used during leg 1. Figures 5a through 5d show the differences for channel 16 the highest sonobuoy frequency, and are typical of good clean track with virtually no RF interference (RFI). Statistics on horizontal position differences for this channel are mean = 7.9 yards, circular standard error = 6.6 yards, and total RMS radial error = 10.3 yards.

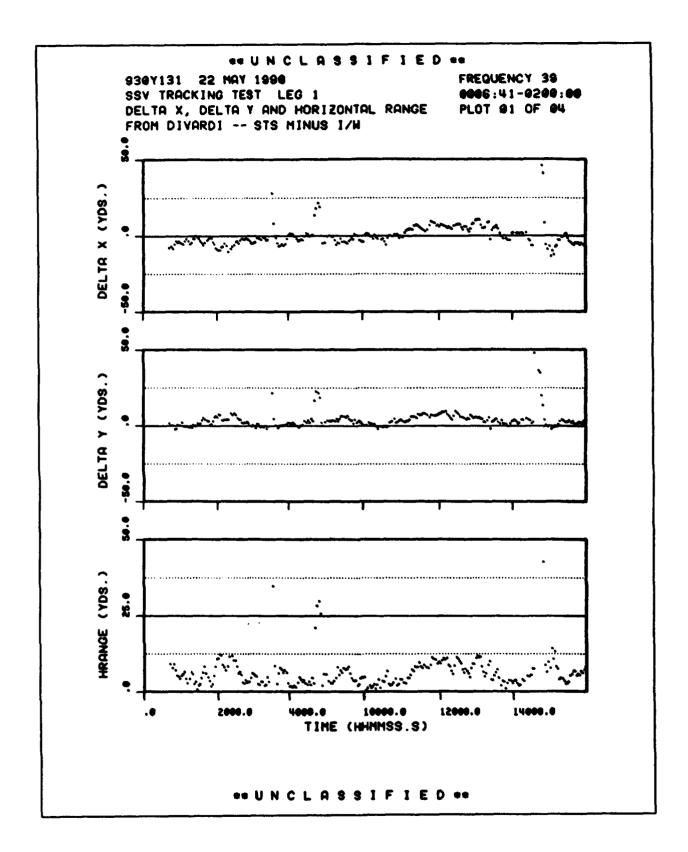
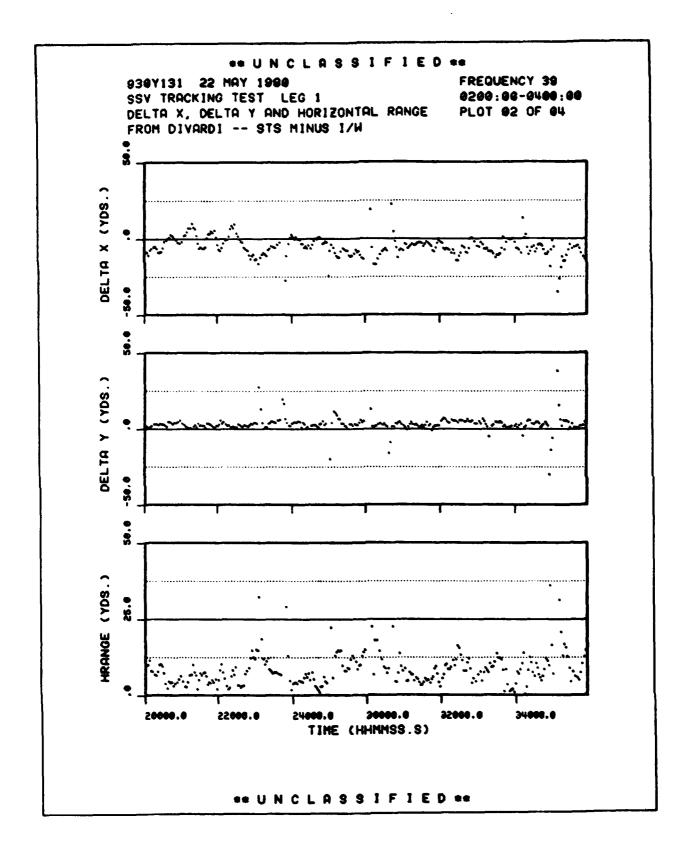
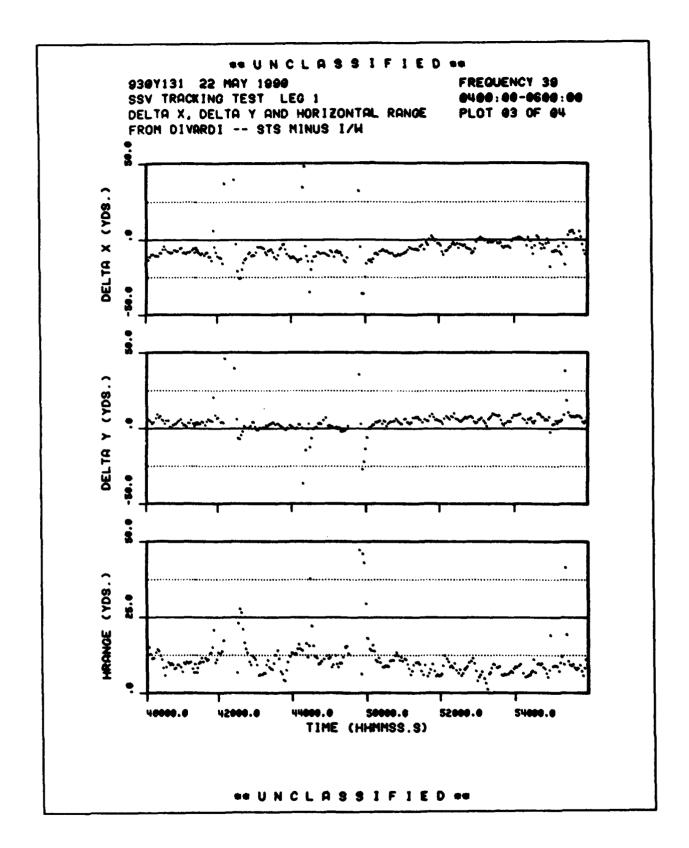
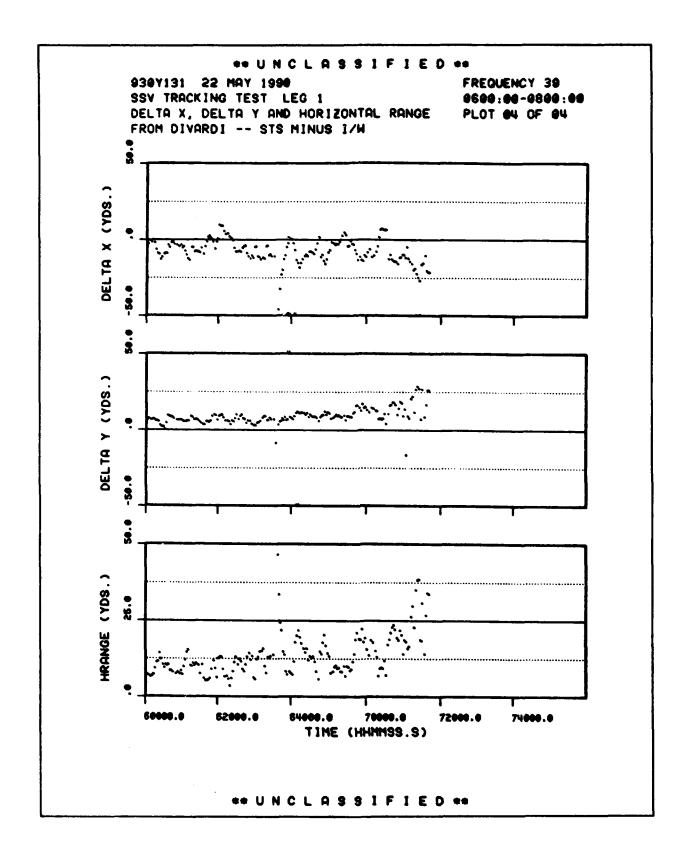
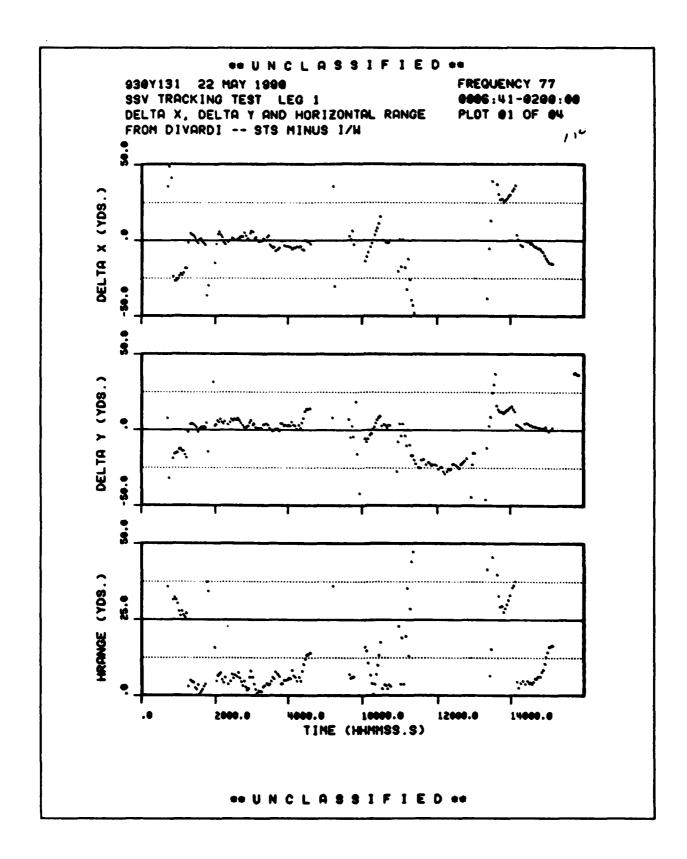
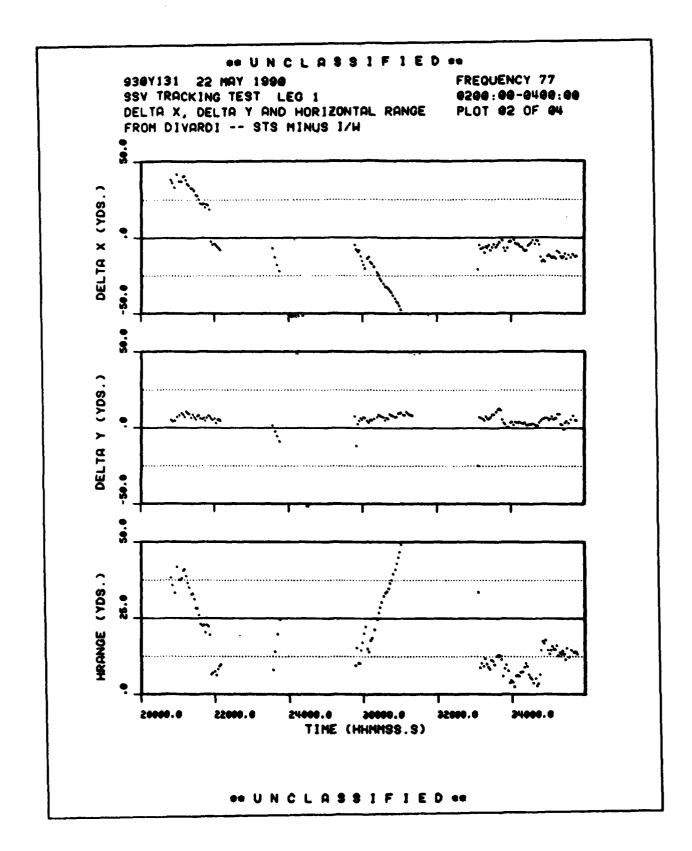
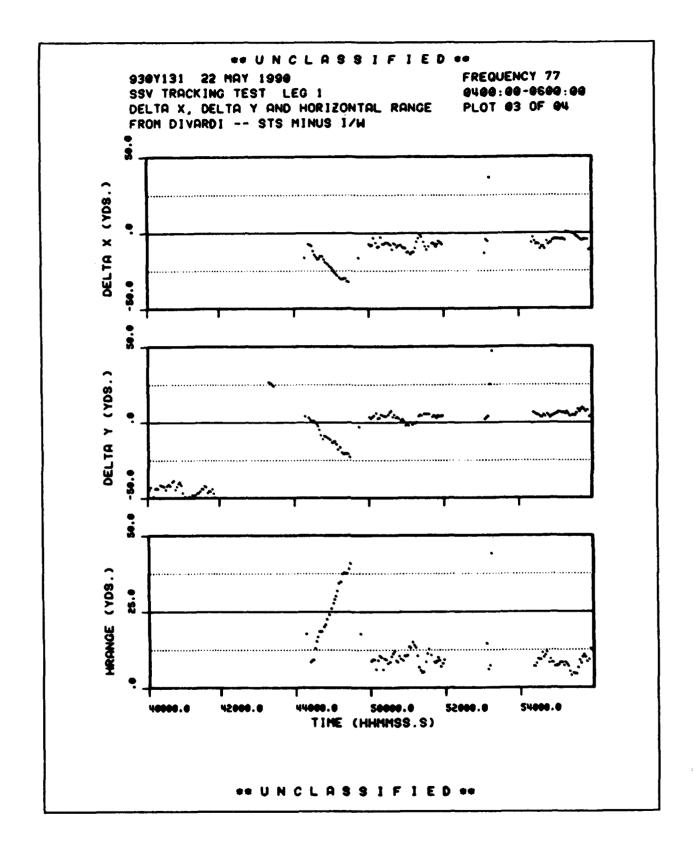
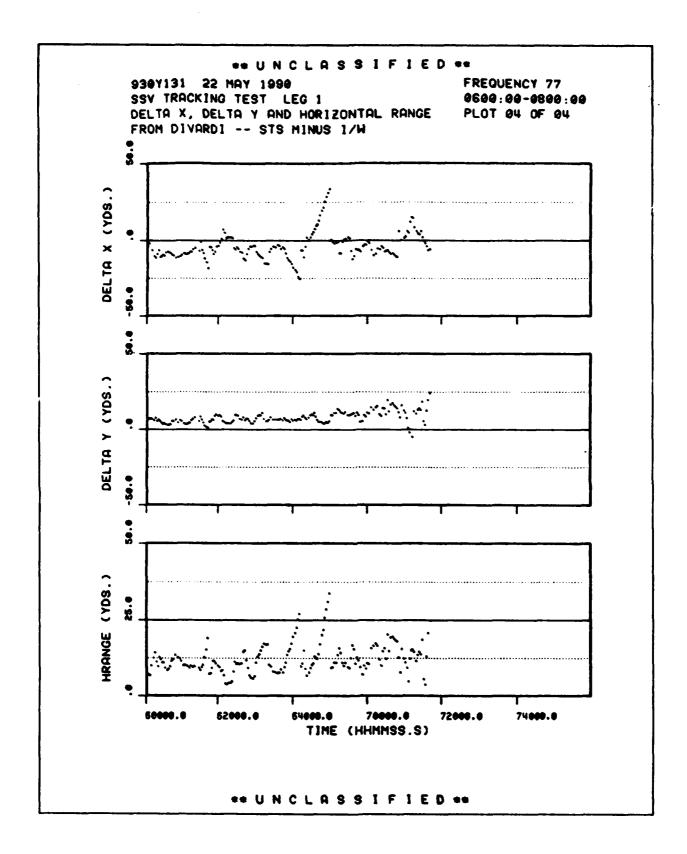
Figures 6a through 6d for channel 39, a low-sonobuoy frequency, also illustrate good track but with occasional spikes because of STS rather than I/W. While this spiking did not jeopardize meeting the STS accuracy requirement, the vendor was asked to examine whether this spiking could be reduced by additional or refined prefilter data editing/rejection. As noted in paragraph 7.4, the vendor reported that he could not make any improvement. Figures 7a through 7d for channel 77, a mid-range frequency, show the effects of severe RFI.

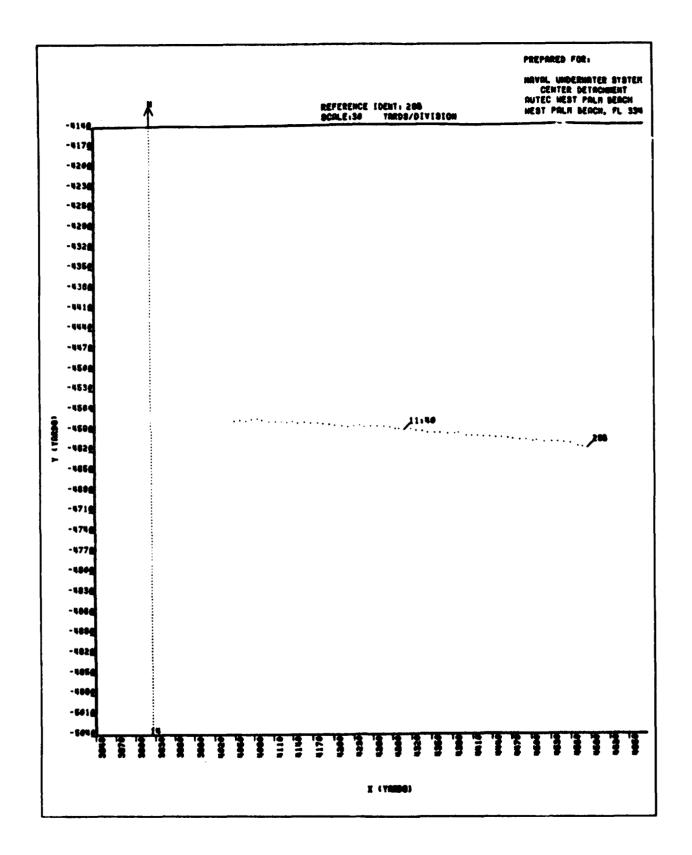
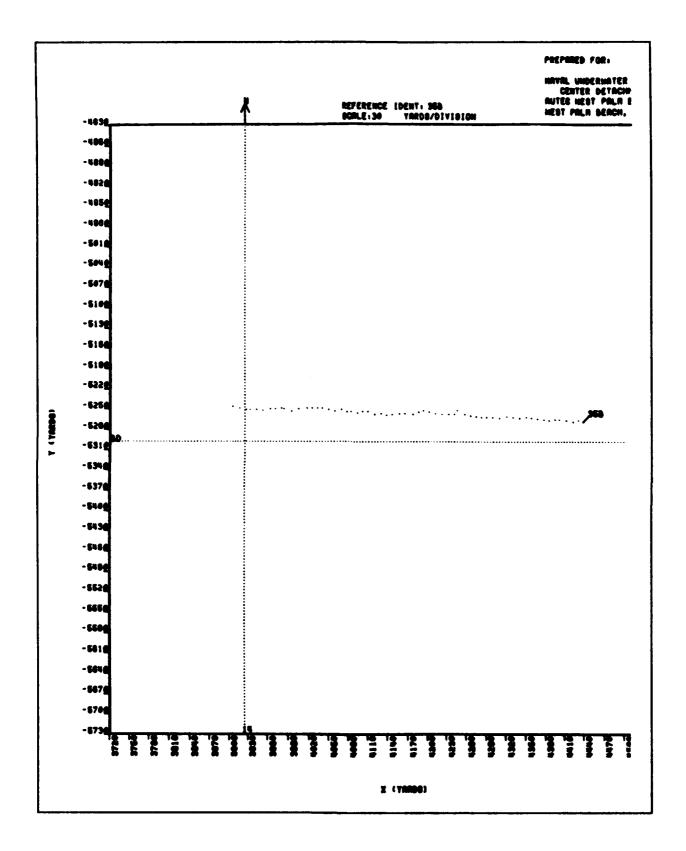
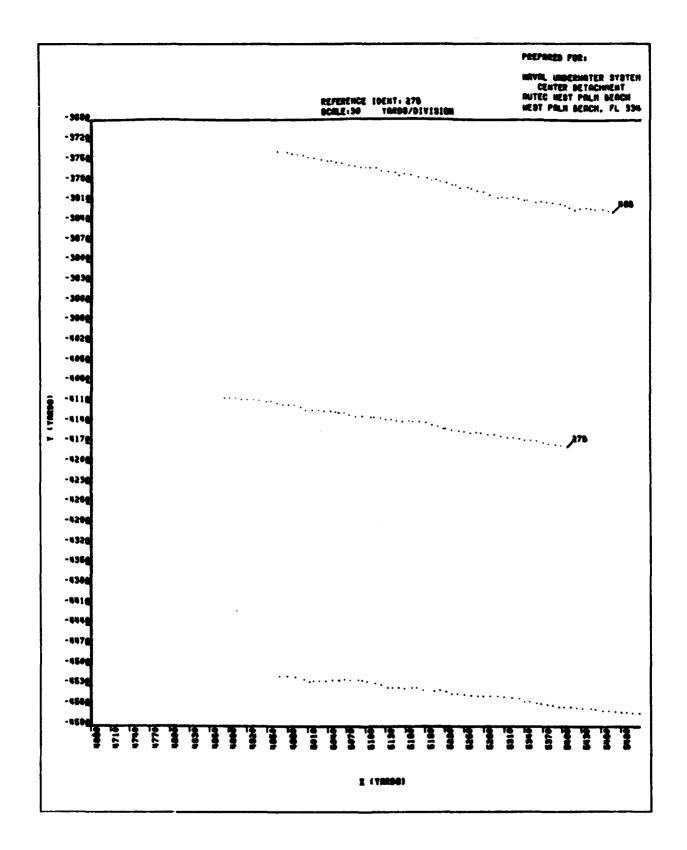
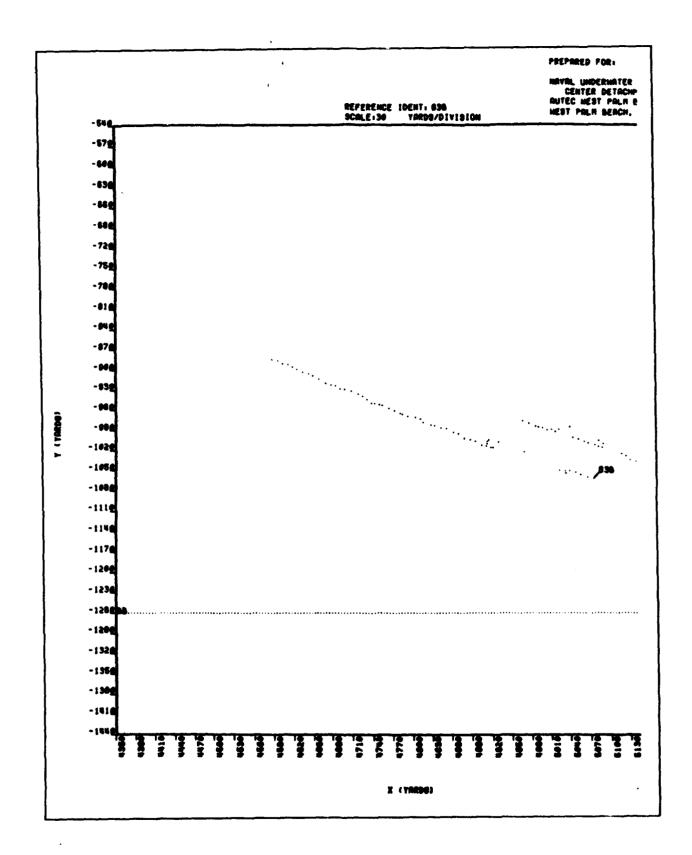
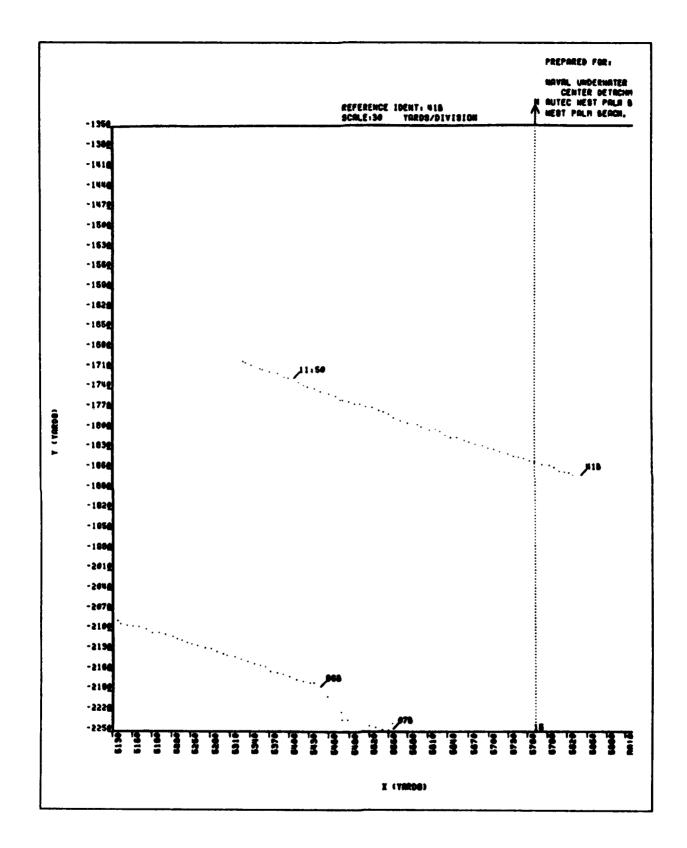
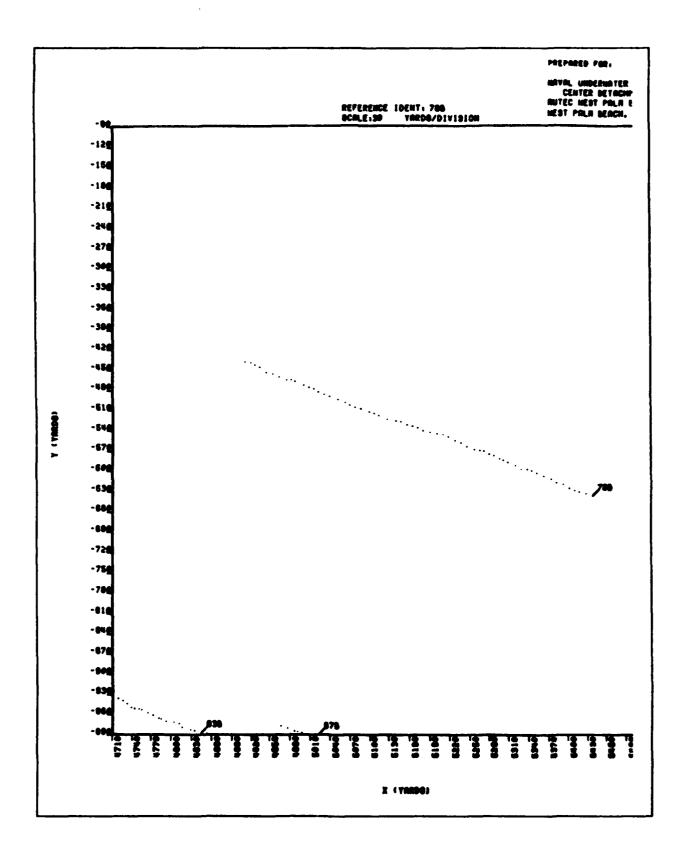
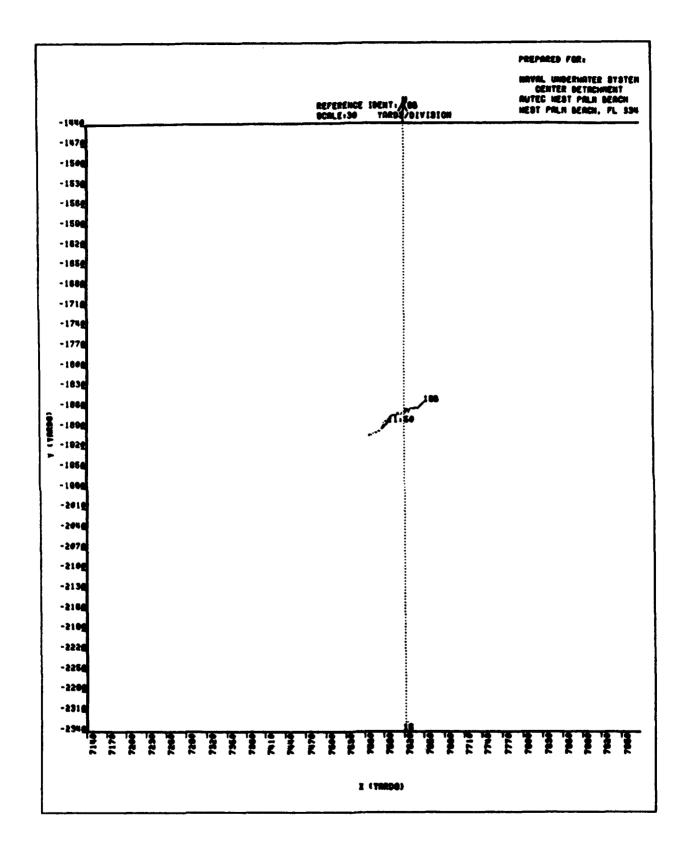
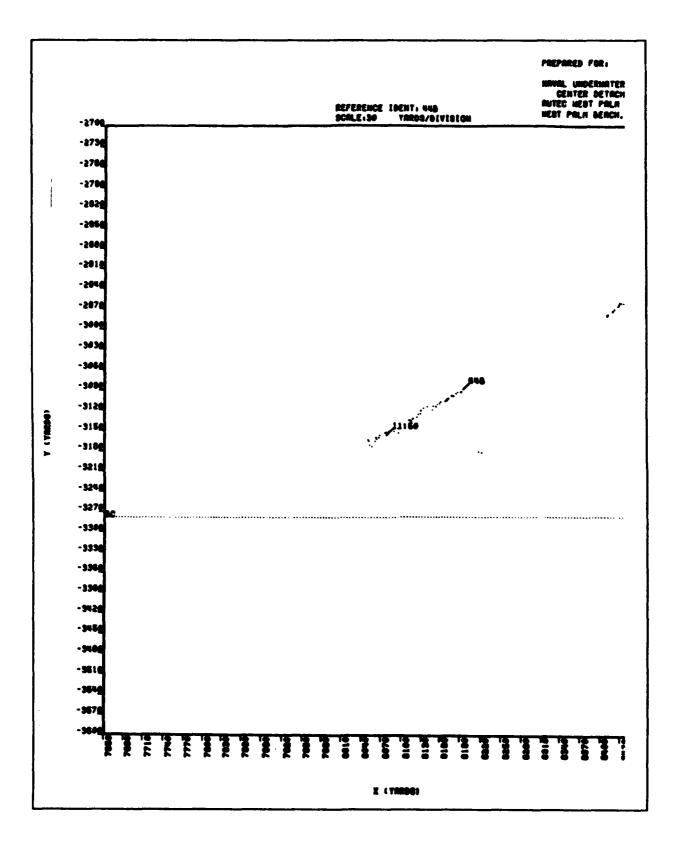
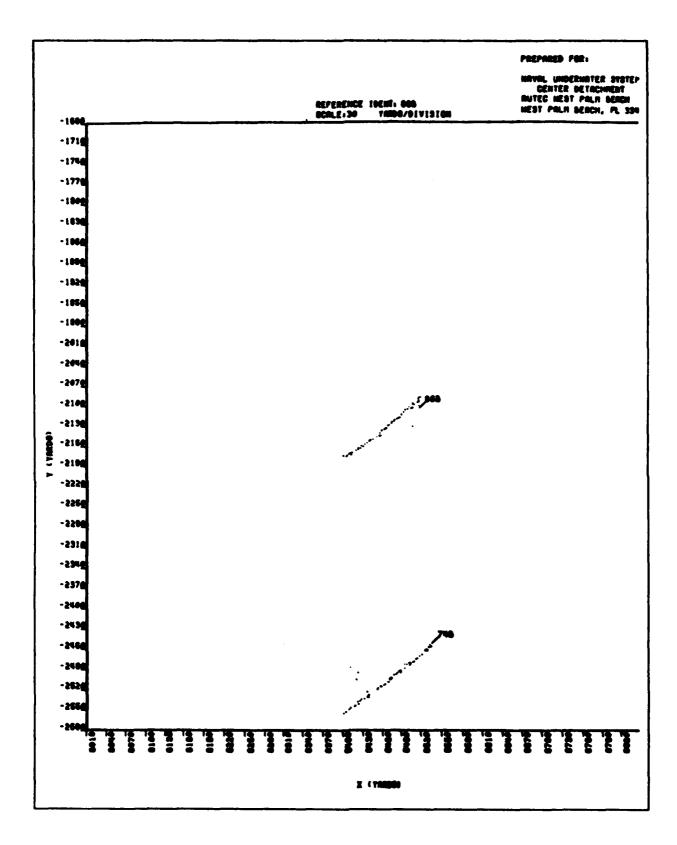
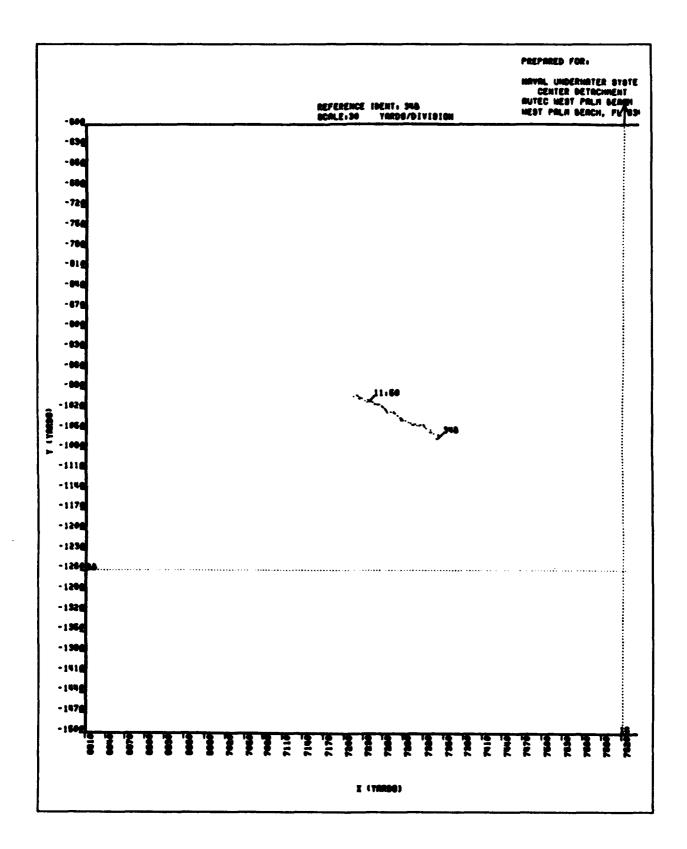
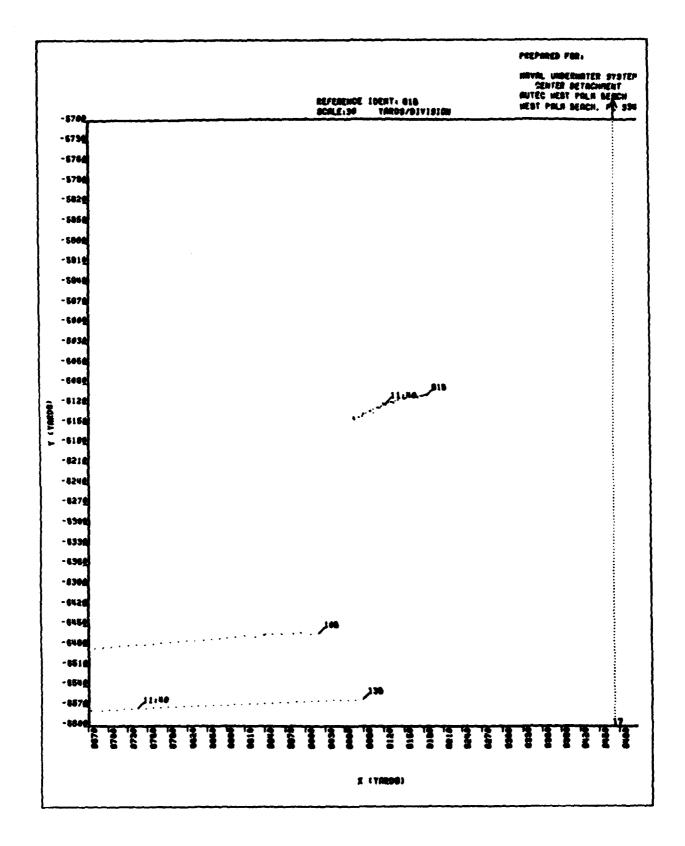
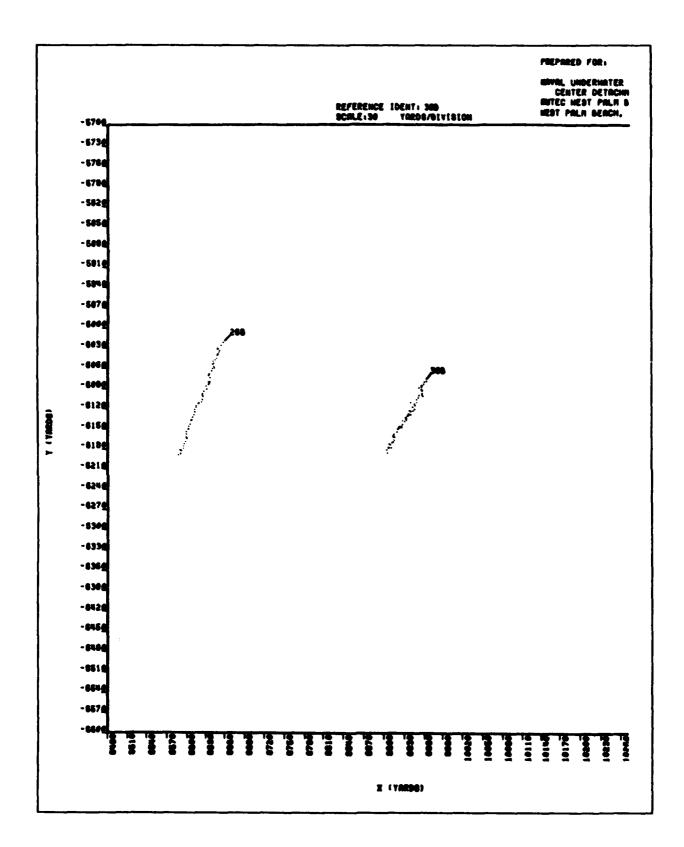
Table III refers to figures 8-12 to give a qualitative evaluation of possible effects of the JETTS pinger packages on course and speed of the sonobuoys tethered to them. In the figures, sonobuoys of interest are identified in the titles by their channel numbers; in the plots themselves, the channel numbers have an uppercase "B" suffix. As shown in table III, little or no effect on three AN/SSQ-53s was observed, but moderate to considerable effect on SSQ-77s' course and speed may have been due to the pinger packages.

TABLE III. EFFECTS OF TETHERED PINGER ON SONOBUOY TRACK							
S/BS with JETTS		S/Bs without JETTS		TYPE			
CHANNELS	FIGURES	CHANNELS	FIGURES	AN/SSQ-	EFFECTS POSSIBLY BECAUSE OF JETTS		
29,35	8,9	46,27,37	10	53	Slight to none		
83	11	41,78	12,13	53	Slight to none		
16	14	44,86	15,16	77	Moderate (speed)		
34	17	44,86	15,16	77	Considerable (course)		
81	18	26,38	19	77	Moderate (course)

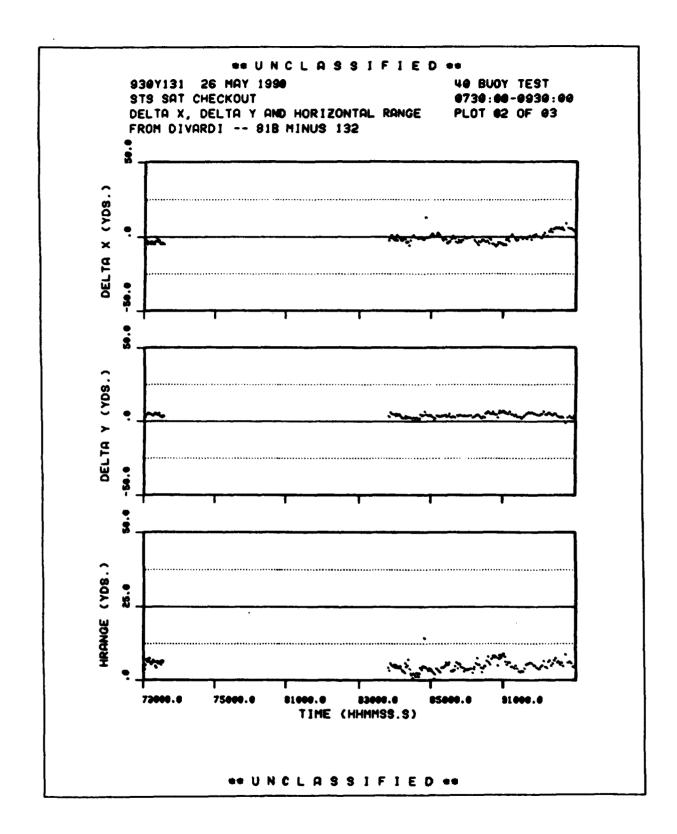
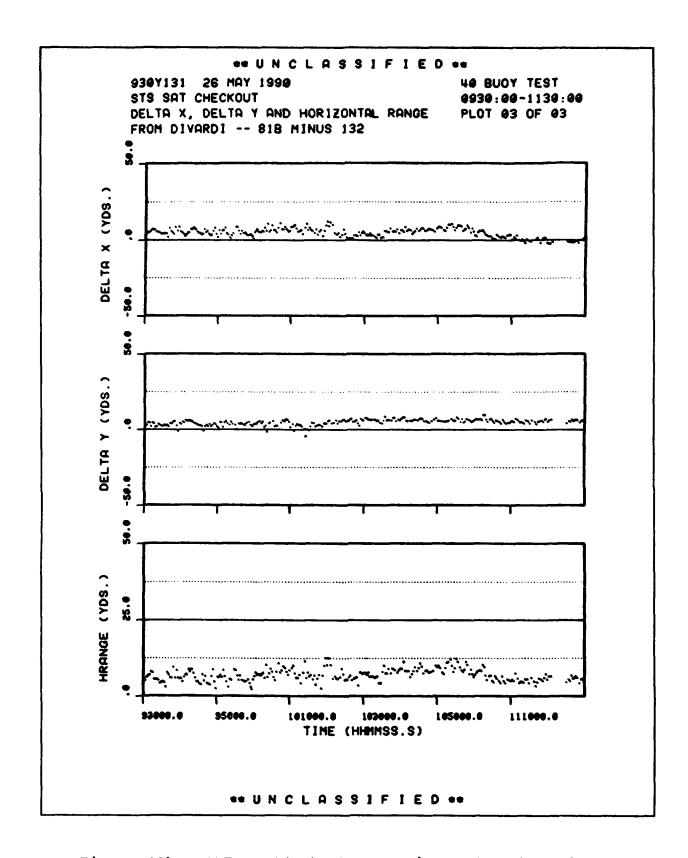
Typical for sonobuoy tracking, figures 22a through 23c are plots of position differences (Delta-X, Delta-Y, and horizontal range) between STS and I/W as a function of time, for two sonobuoy channels. Figures 22a and b for channel 81, a mid-range frequency, show good, clean STS track; (statistics on horizontal position differences for this channel: mean = 6.6 yards, circular standard error = 2.5 yards, total RMS radial error = 7.0 yards). Figures 23a through 23c for channel 29, a high sonobuoy frequency, also shows good track but with some of the spiking experienced with SSV tracking, as mentioned previously and in subparagraph 7.4(a).

Figure 22a. SAT 40 S/B test, STS minus I/W, channel 81.

Figure 22b. SAT 40 S/B test, STS minus I/W, channel 81.

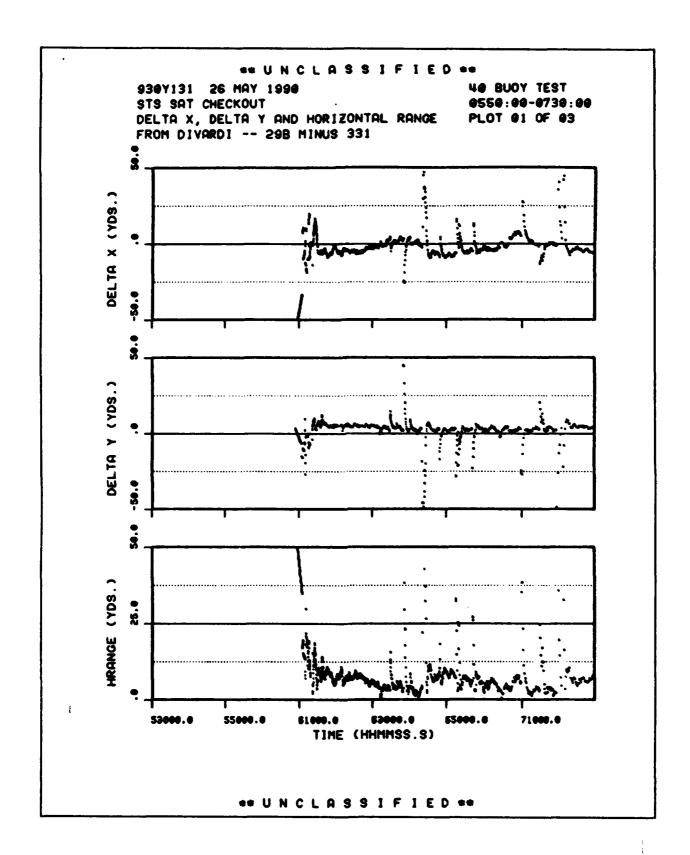
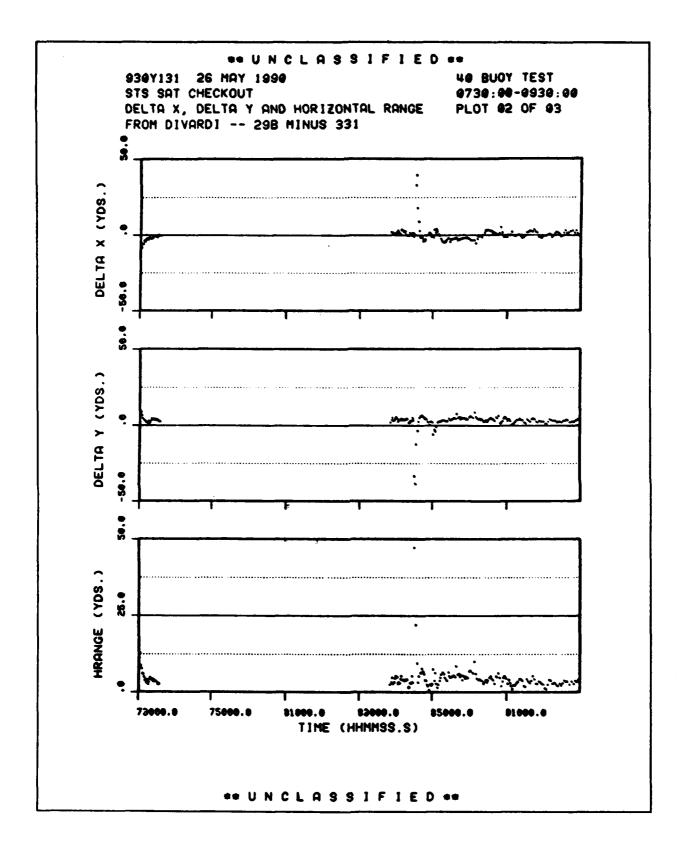
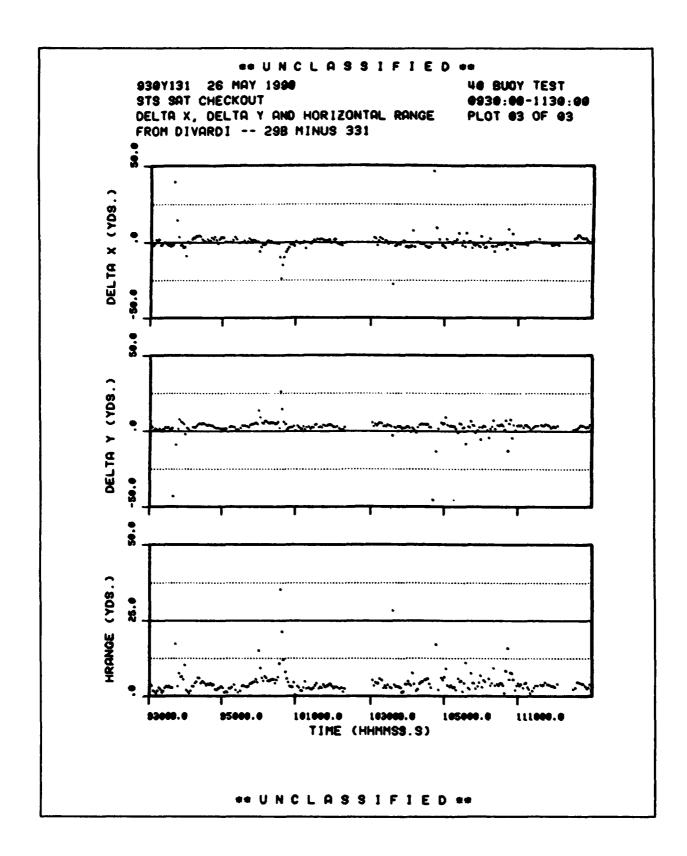
Figure 23a. SAT 40 S/B test, STS minus I/W, channel 29.

Figure 23b. SAT 40 S/B test, STS minus I/W, channel 29.

Figure 23c. SAT 40 S/B test, STS minus I/W, channel 29.

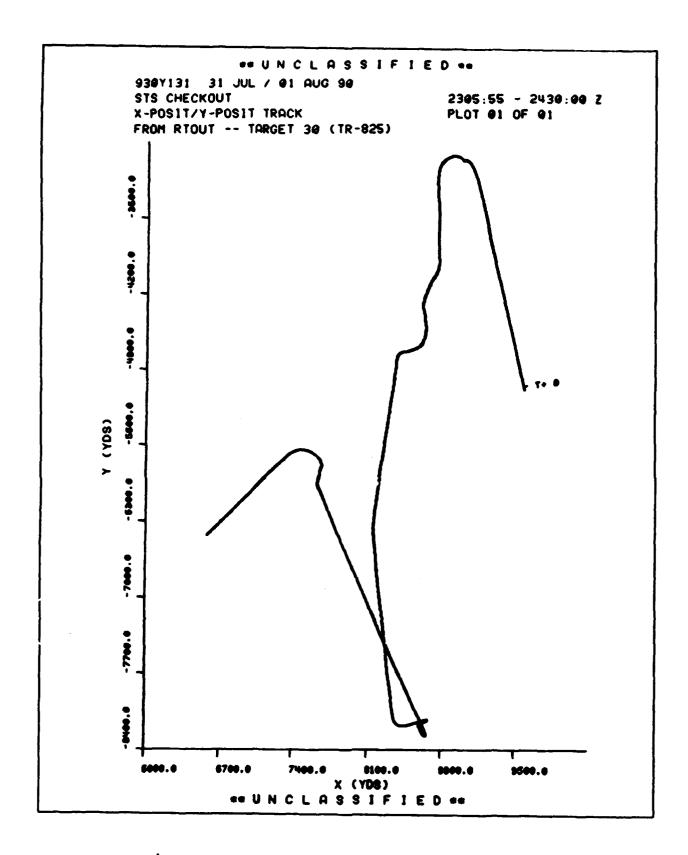
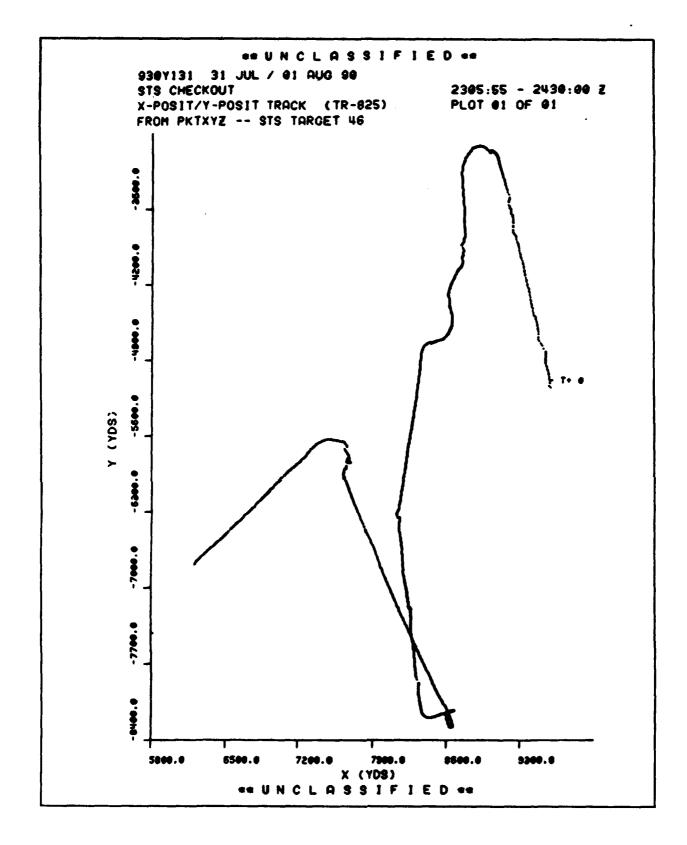
The test consisted of the STS tracking an SRT-22 portable sonobuoy simulator aboard the TR-825, (plus two sonobuoys in the water). The TR-825 maneuvered at various speeds and headings for approximately 1.5 hours. Figures 24 and 25 show the TR-825's track during the test as determined by I/W and by the STS.

Figure 24. Post-SAT, boat track from I/W.

Figure 25. Post-SAT, boat track from STS.

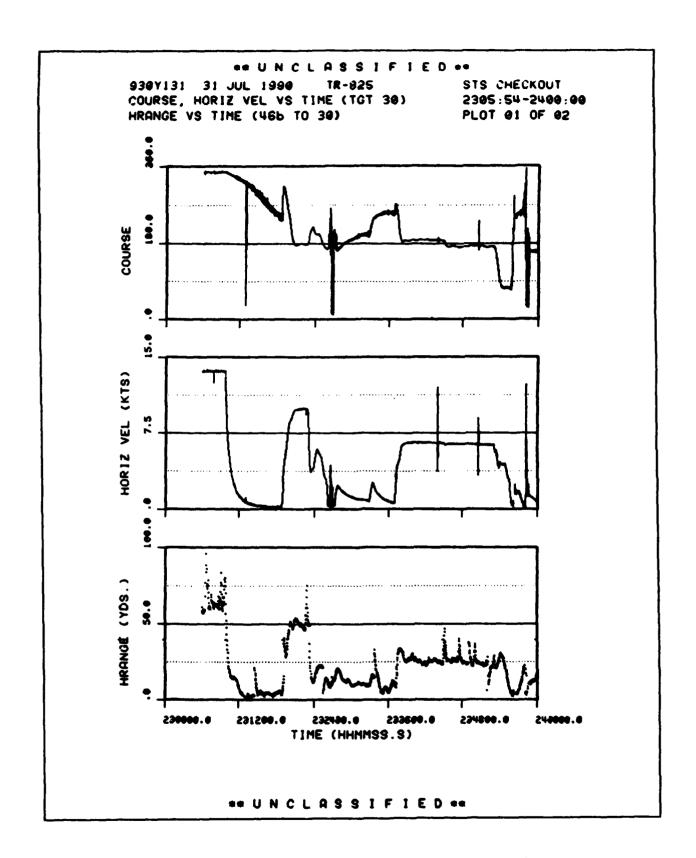
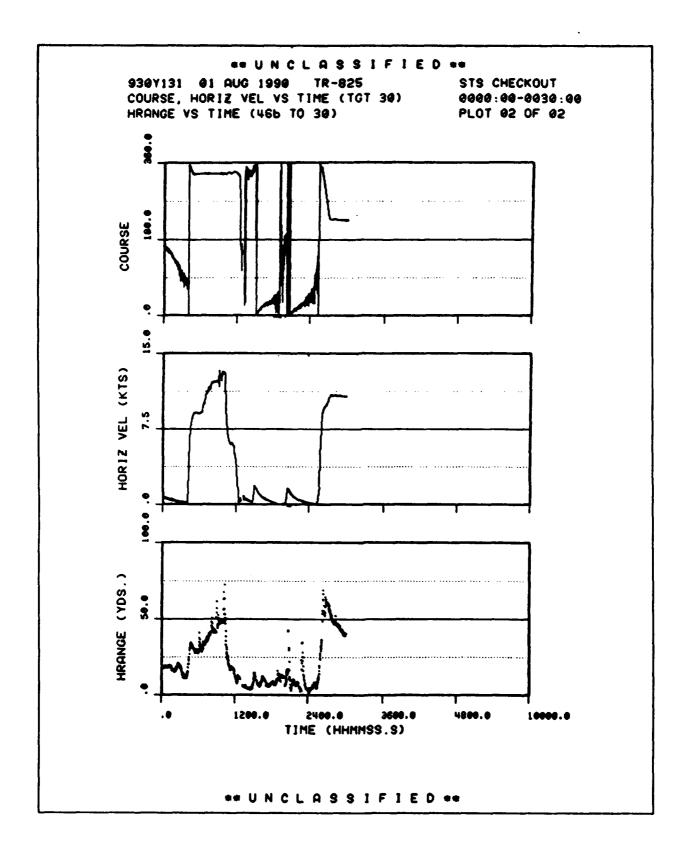
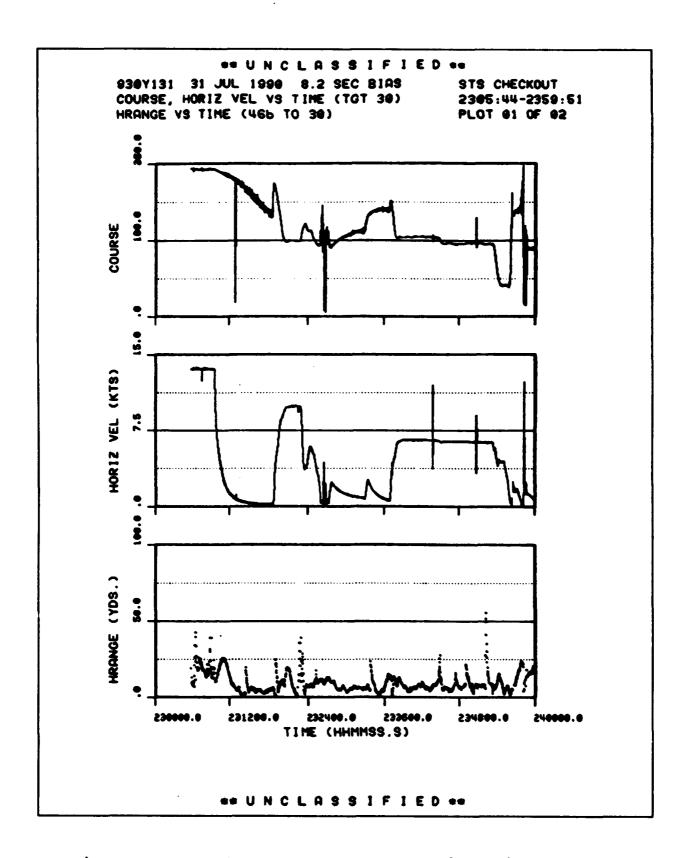
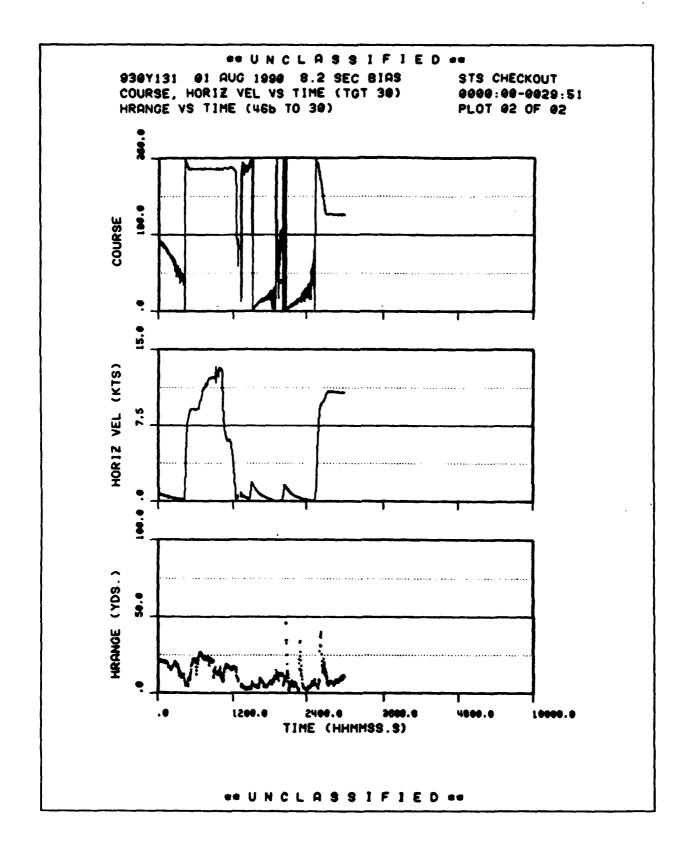
Time-shifting STS data by several of these delay estimates, and reprocessing the STS-I/W difference data showed that an 8.2 second time bias correction gave the best results, and virtually eliminated the correlated error, as shown in figures 30a and b (compare with figures 29a and b) and in figures 31a and b (compare with figures 27a and b). Plots versus time of the STS-I/W differences, after time-delay correction, are shown in figures 32a and b (compare with figures 26a and b).

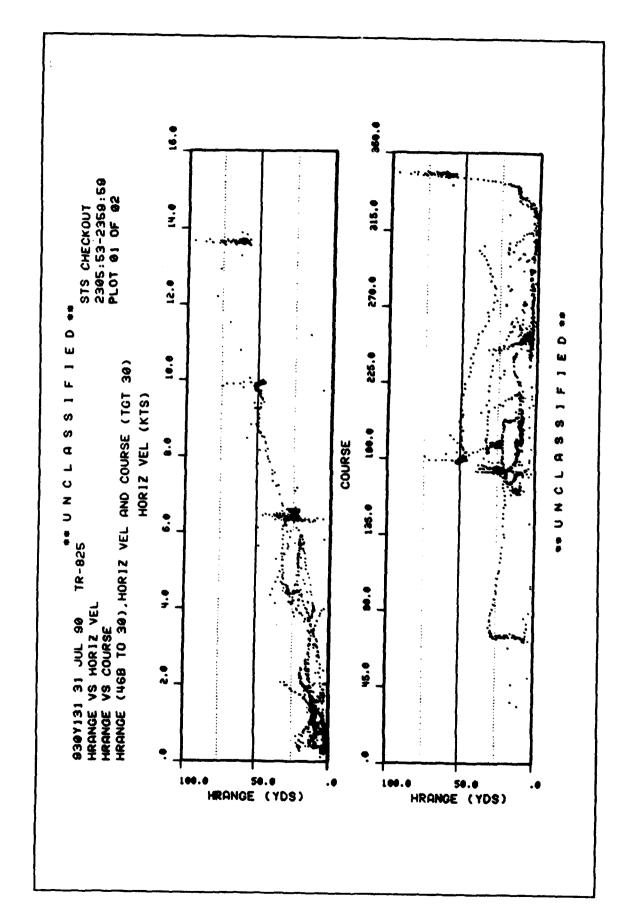
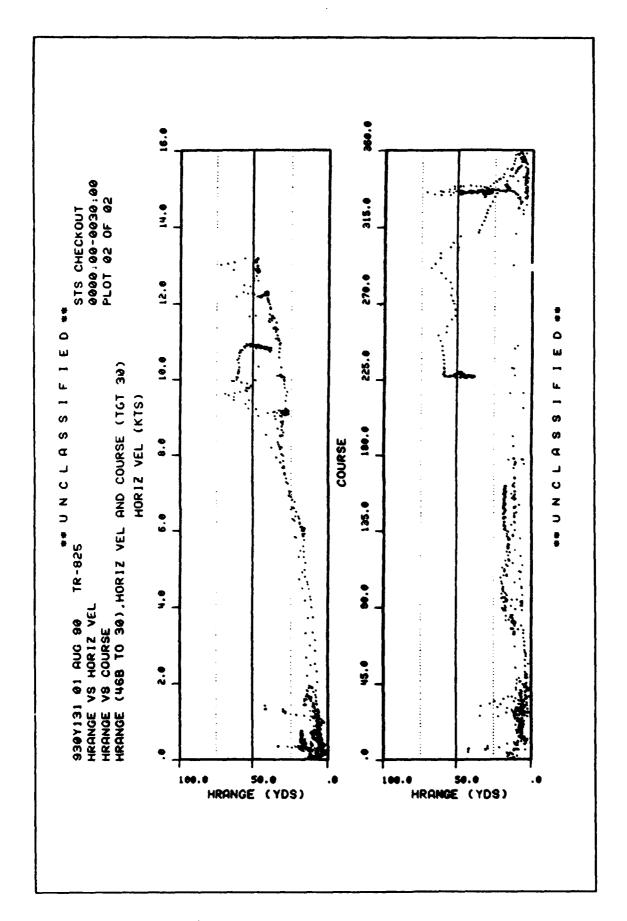
This high correlation between speed and error is confirmed by the upper portions of figures 27a and b, where horizontal range between STS and I/W is plotted versus speed (upper) and versus course (lower).

Post-SAT, STS-I/W versus velocity and course. Figure 27a.

Post-SAT, STS-I/W versus velocity and course. Figure 27b.
